Water Temperature Study 2010: Thornton and Rush Rivers

Prepared by BJ Valentine for Rapp FLOW
10/20/2010

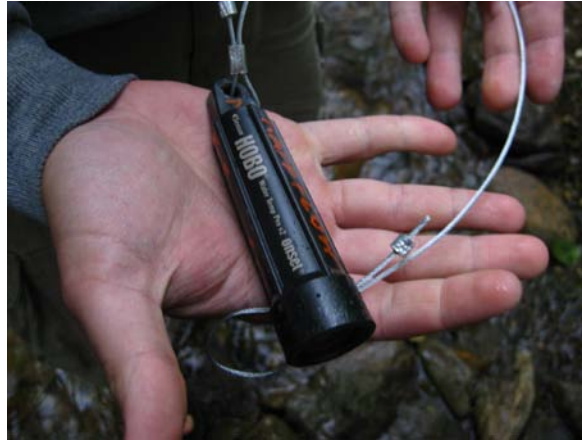
Figure 1. HOBO Water Temp Pro V2 temperature logger with cable.

These loggers were anchored at each monitoring site with a thin diameter cable, and were placed either in a riffle or pool section. Most of the loggers were placed in May of 2010 and were collected in early October. Data was then retrieved using a data shuttle and HOBO software.

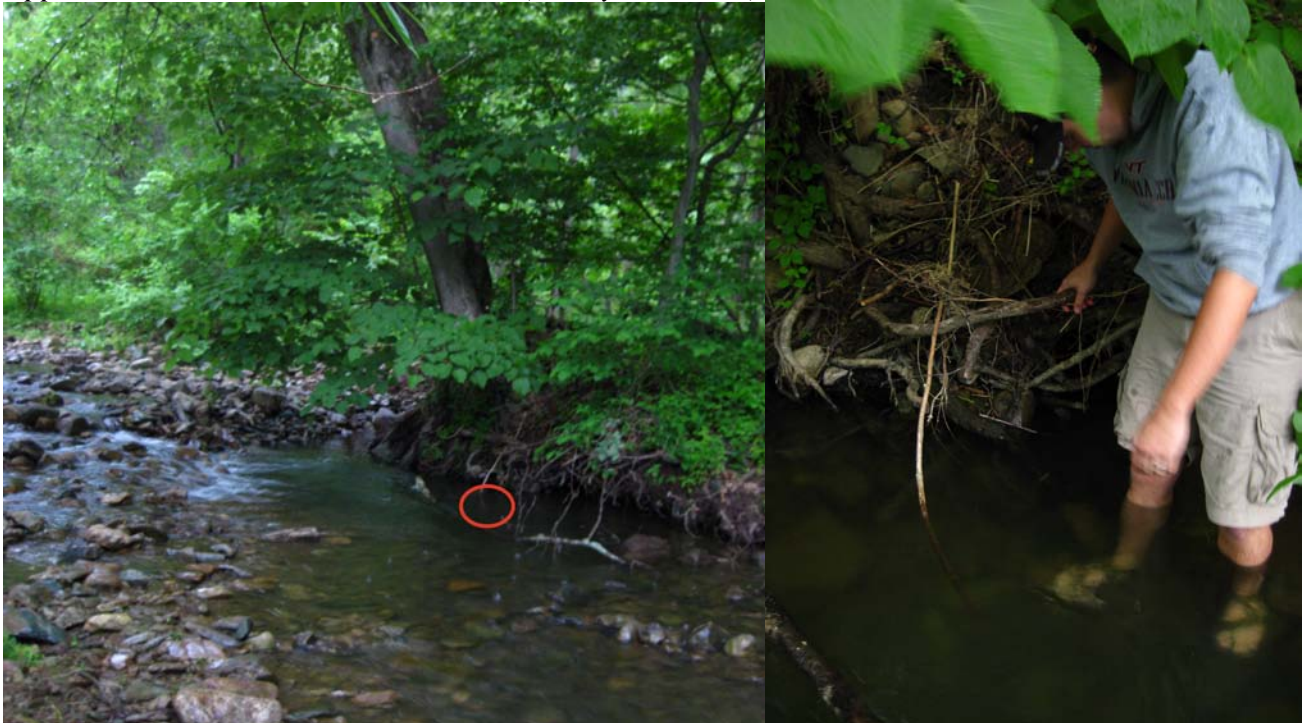
Figure 2. Temperature logger location on Harris Hollow Rd. The Red oval marks the temperature logger's position in stream. Photo to the right shows the depth of the pool on 5/19/10.

HOBO temperature logger was installed on 5/19/2010 off of Harris Hollow Road in a knee deep pool under a basswood. Both sides of the stream are vegetated with trees and shrubs providing a fairly good canopy for shade. Data logger was removed on 10/13/10. The pool was still knee deep (17-18 inches), but due to the summer's drought conditions it is suspected that during the summer the flow was severely reduced. When retrieving the logger, fish were observed in the pool but they could not be positively identified.

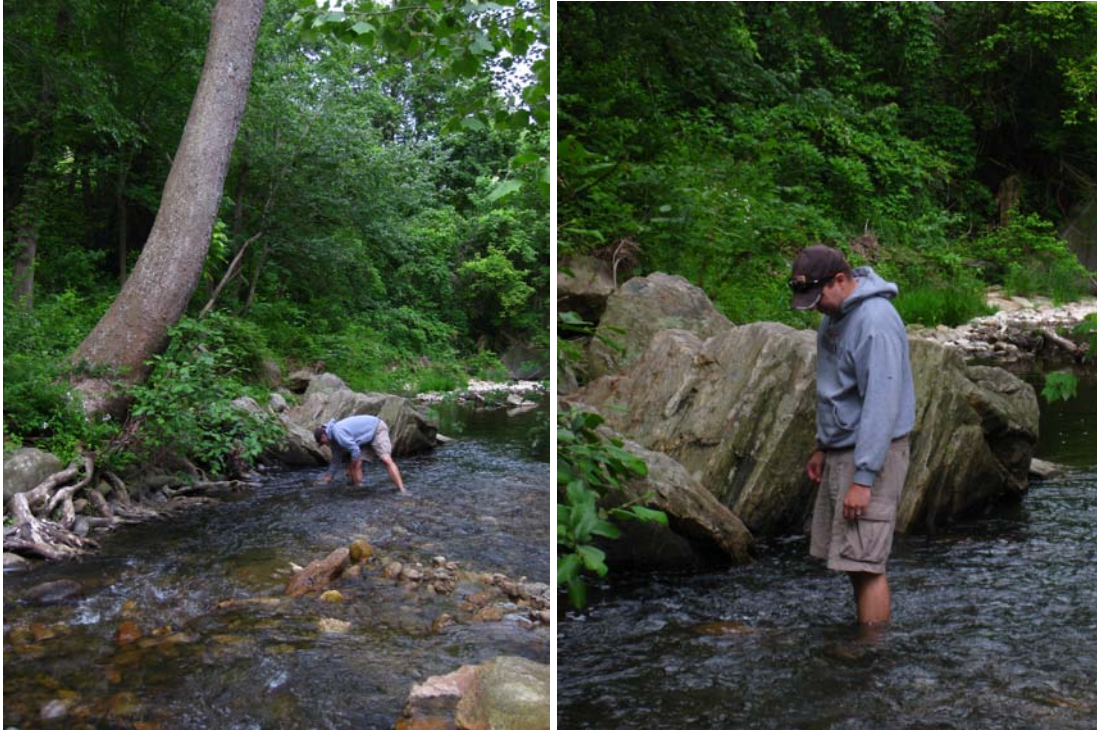
Figure 3. Rapp FLOW volunteer placing temperature logger between Old Mill Rd bridge and the US 211 bridge. The photo to the right shows the water depth on 5/19/10.

Temperature logger was established on 5/19/10 between the bridges of Old Mill Rd and US 211. The probe was attached to the root mass of a sycamore and placed in a riffle section just before going into a deep pool. Water was only about a foot deep on 5/19/10. Probe was collected on 10/13/10. Water levels were about three to four inches shallower than when the probe was installed, but water levels were extremely low during the summer months. Even though the site has large mature sycamores, the canopy is fairly open compared to most sites in the study. The edges along the stream are well established. On 10/13/10 volunteers observed about 8 tires that have been dumped downstream of the Old Mill Rd bridge.

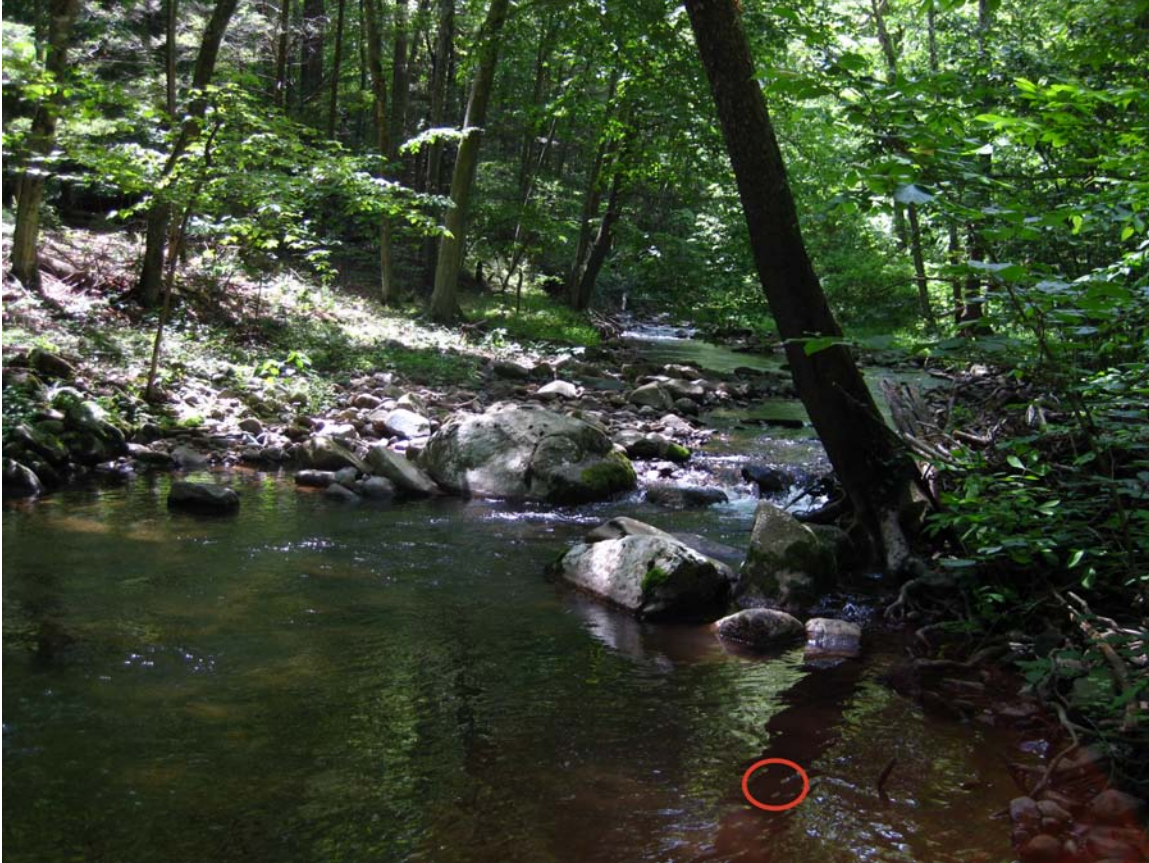
Figure 5. Temperature logger location on the Upper North Fork of the Thornton River on the Fitzhugh's Property. Red oval marks the temperature loggers position in the stream.

Temperature logger was established on 5/20/10 off of Old Hollow Rd, roughly a mile downstream from the Shenandoah National Park boundary. The probe was attached to a root mass and placed in a backwater section of a pool. Water was only about a 6-7 inches deep on 5/20/10. Probe was collected on 10/13/10, with water levels at about 5-6 inches deep. Site is well shaded and protected with mature hardwood trees and understory shrubs.

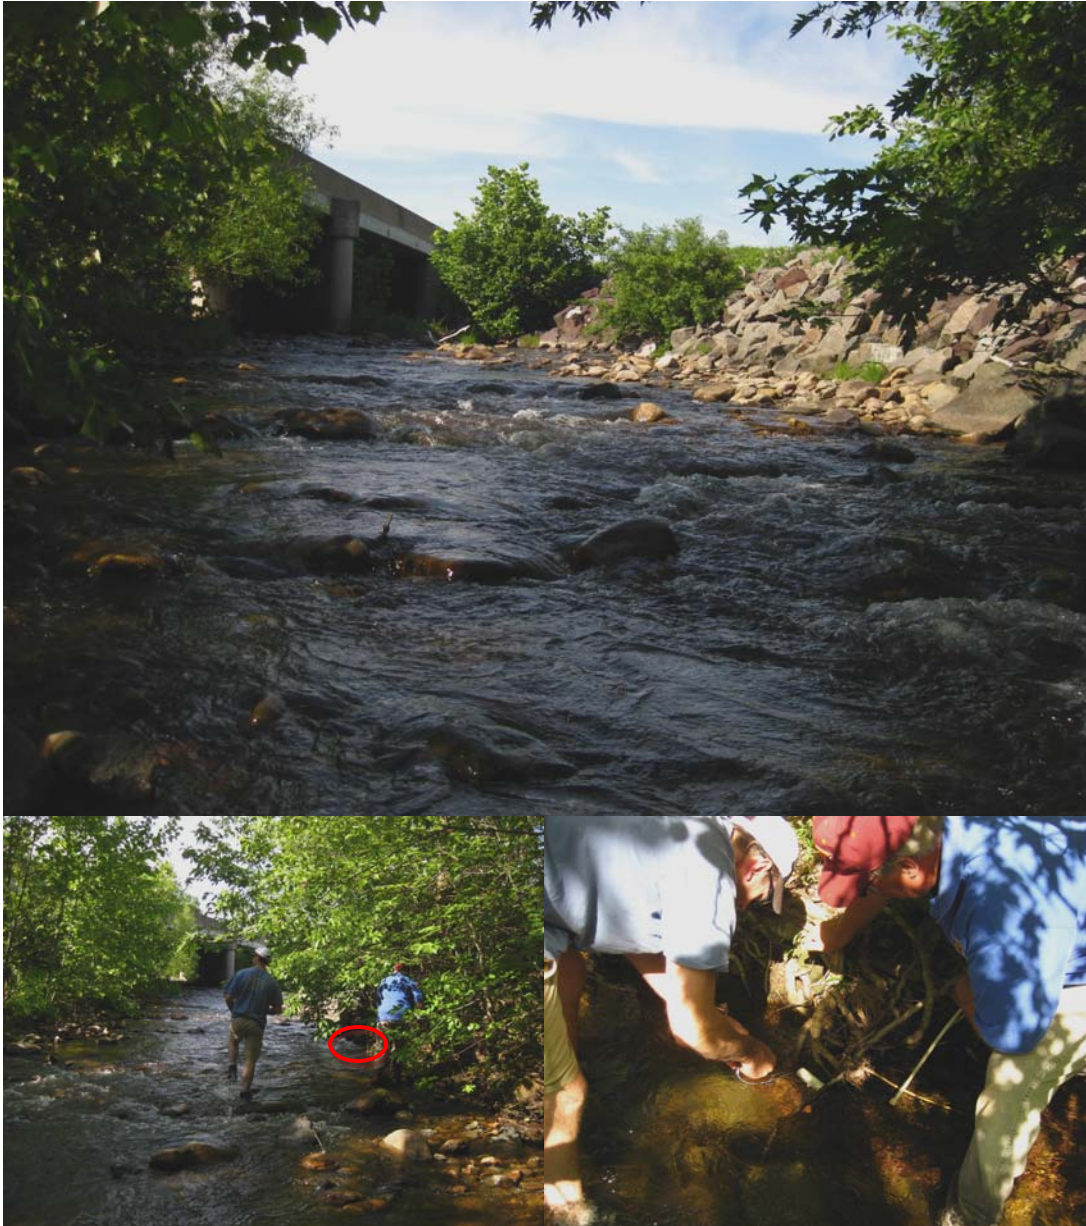
Figure 6. Temperature logger location on the lower north fork of the Thornton River at Mount Vernon Farm. The temperature logger was established by Trout Unlimited. The red oval marks the location of the temperature logger. The image to the lower right show how the temperature logger cable is attached to a root mass. Once fixed to the root mass, the logger is covered with river cobbles and stones.

Temperature logger was established on 5/16/10 just downstream from the US 211 bridge at Mount Vernon Farm. The probe was attached to a root mass and placed in a riffle section. Water was only about a 5-6 inches deep on 5/16/2010. Probe was collected on 10/5/10, with water levels at about 4-5 inches deep. Site is shaded on both sides of the stream with mature sycamores and shrubs, but approximately thirty-five feet upstream the channel on one side of the stream bank is rip-rapped with rock and has little to no

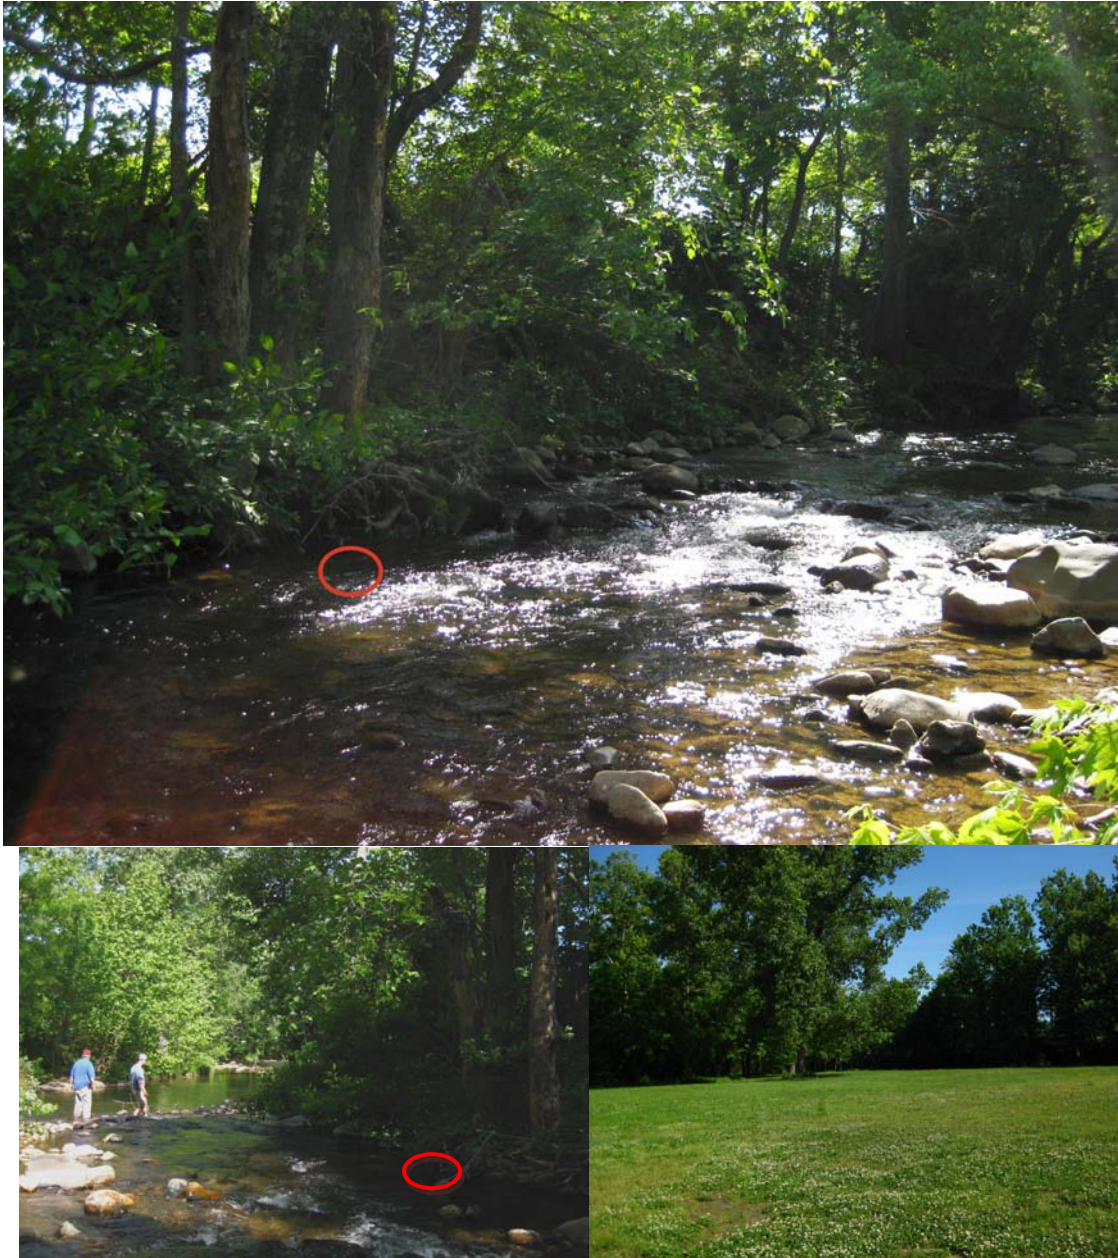
Figure 8. Temperature logger location on the lower south fork of the Thornton River just before the confluence of the forks at Copper Fox Antiques. The red oval marks the location of the temperature logger. The image to the lower left shows the confluence of the north and the south forks. In the lower left hand image, the South fork is at the tree line in the background. Only one wide of the stream is fully vegetated with trees and shrubs.

Temperature logger was established on 5/20/10 just downstream from the US 211 bridge at Mount Vernon Farm. The probe was attached to a root mass of a large sycamore and placed in a pool. Water was only about 16-17 inches deep on 5/20/2010. Probe was collected on 10/13/10, with water levels at about 17-18 inches deep. Site is shaded on

one side by a narrow buffer of mature hardwoods with a shrub understory. The stream bank on the side towards the Copper Fox is grassed and open.
